NASA/TM-2001-210846

Structural Testing of a Stitched / Resin Film Infused Graphite-Epoxy Wing Box

*Dawn C. Jegley and Harold G. Bush
Langley Research Center, Hampton, Virginia*

April 2001

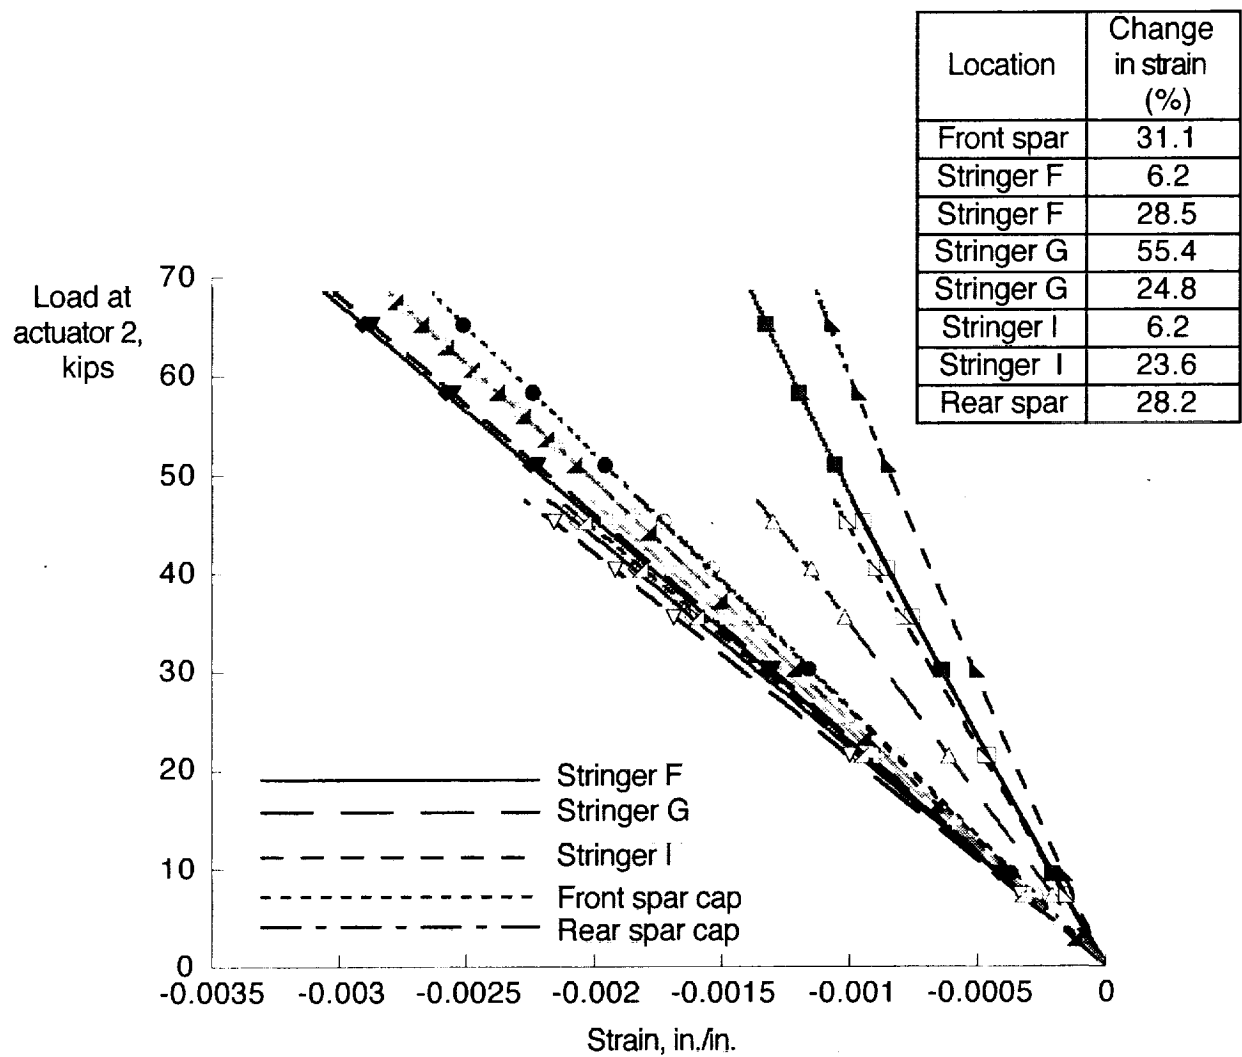
b) Effect of sawcut on measured strains in upper cover panel between ribs 10 and 11

Strains in the same stringer bay as the sawcut but away from the sawcut tips are shown in figure 63a for the lower cover panel and figure 63b for the upper cover panel. Strains in the lower cover panel between ribs 8 and 9 at stringers B and D, at the access hole, and in the wide skin bay region outboard of stringer J are shown. Strain gage locations are shown in figure 7. Strains in the sawcut structure are 4 to 6 percent greater than strains in the undamaged structure at the access hole and approximately the same elsewhere in that bay.

Figure 63. Concluded.

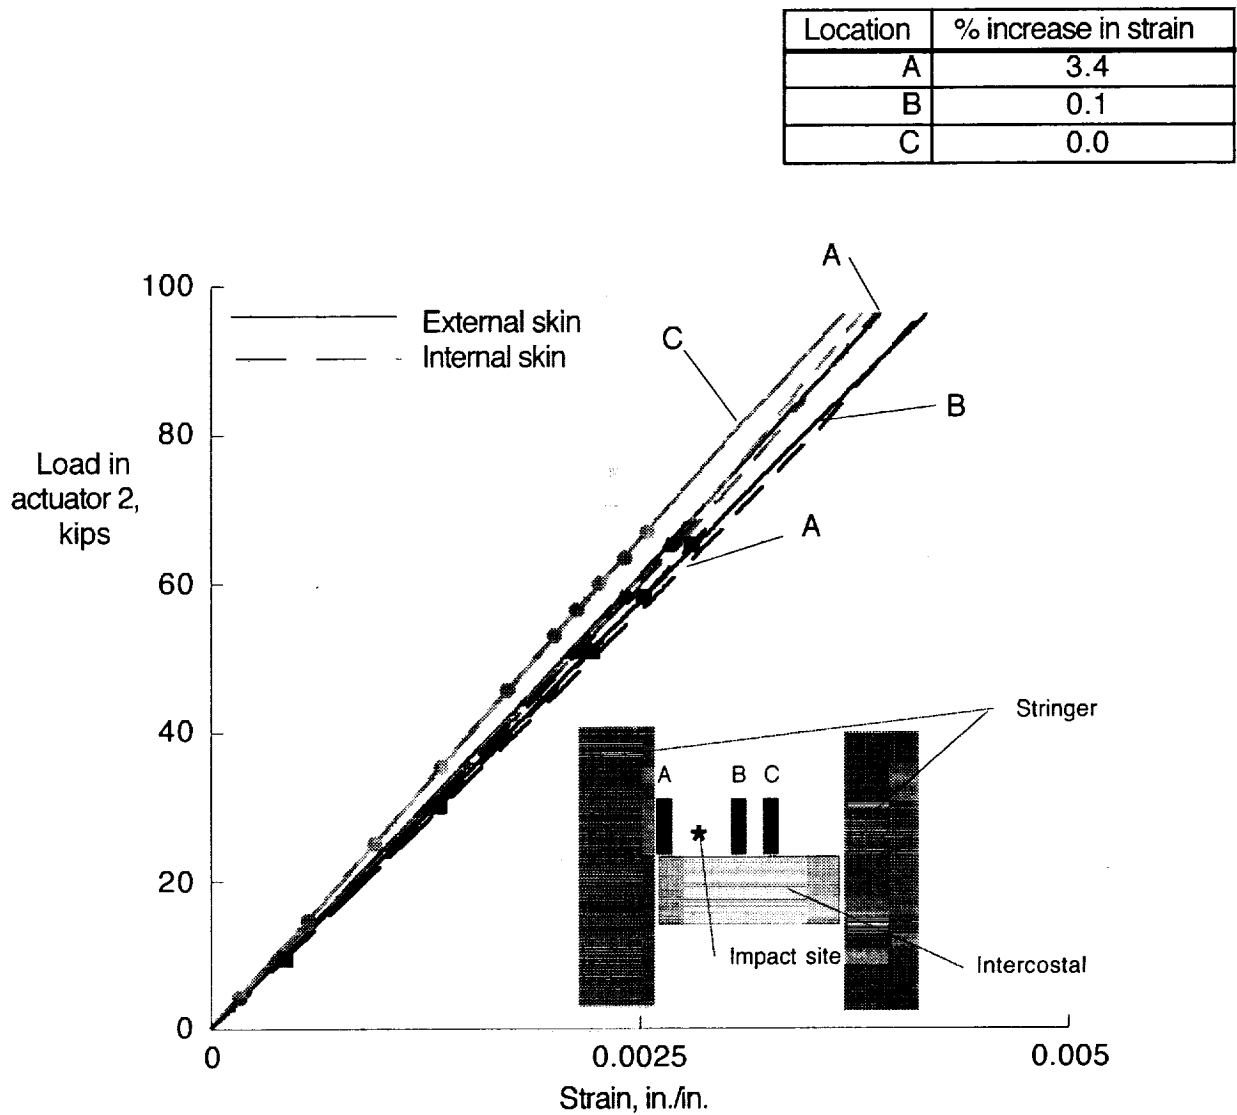
Strains in lower cover panel with impacts are shown in figures 71, 72 and 73 for impact sites at rib 4, rib 8 and rib 12, respectively. Internal strains are shown with dashed lines and external strains are shown with solid lines. The lines with filled symbols represent strain of the undamaged structures. Strains within 1 inch of the impact site remain linear and increase by less than 4 percent compared to strains in the undamaged structure for the impacts at the three impact sites. The impact at rib 12 was originally intended to be at rib 13 (shown in figure 1), so the test article was strain gaged with the corresponding gage pattern. However, the impact site had to be moved because it was impossible to impact the lower cover so close to the rib 13 load saddle. Internal gages could not be moved or added to the rib 12 location. So strains at the rib 12 impact site can only be compared to one gage on the undamaged structure, as shown in figure 73.

Figure 71. Effect of impact damage on strains in lower cover panel skin adjacent to rib 4. Strain gage and impact locations are shown on figure 13a.

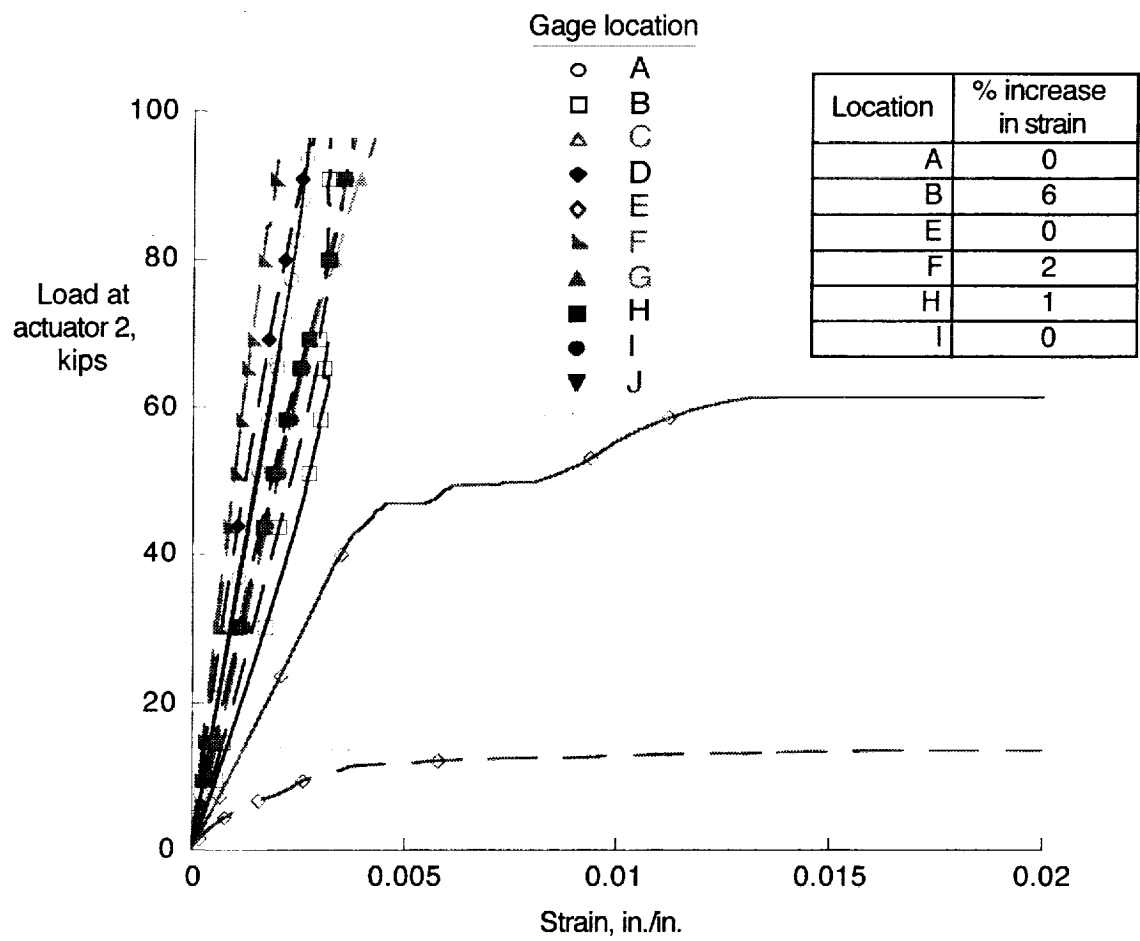
Figure 72. Effect of impact damage on strains at lower cover stringer runout at rib 8. Strain gage locations are shown on figure 3.

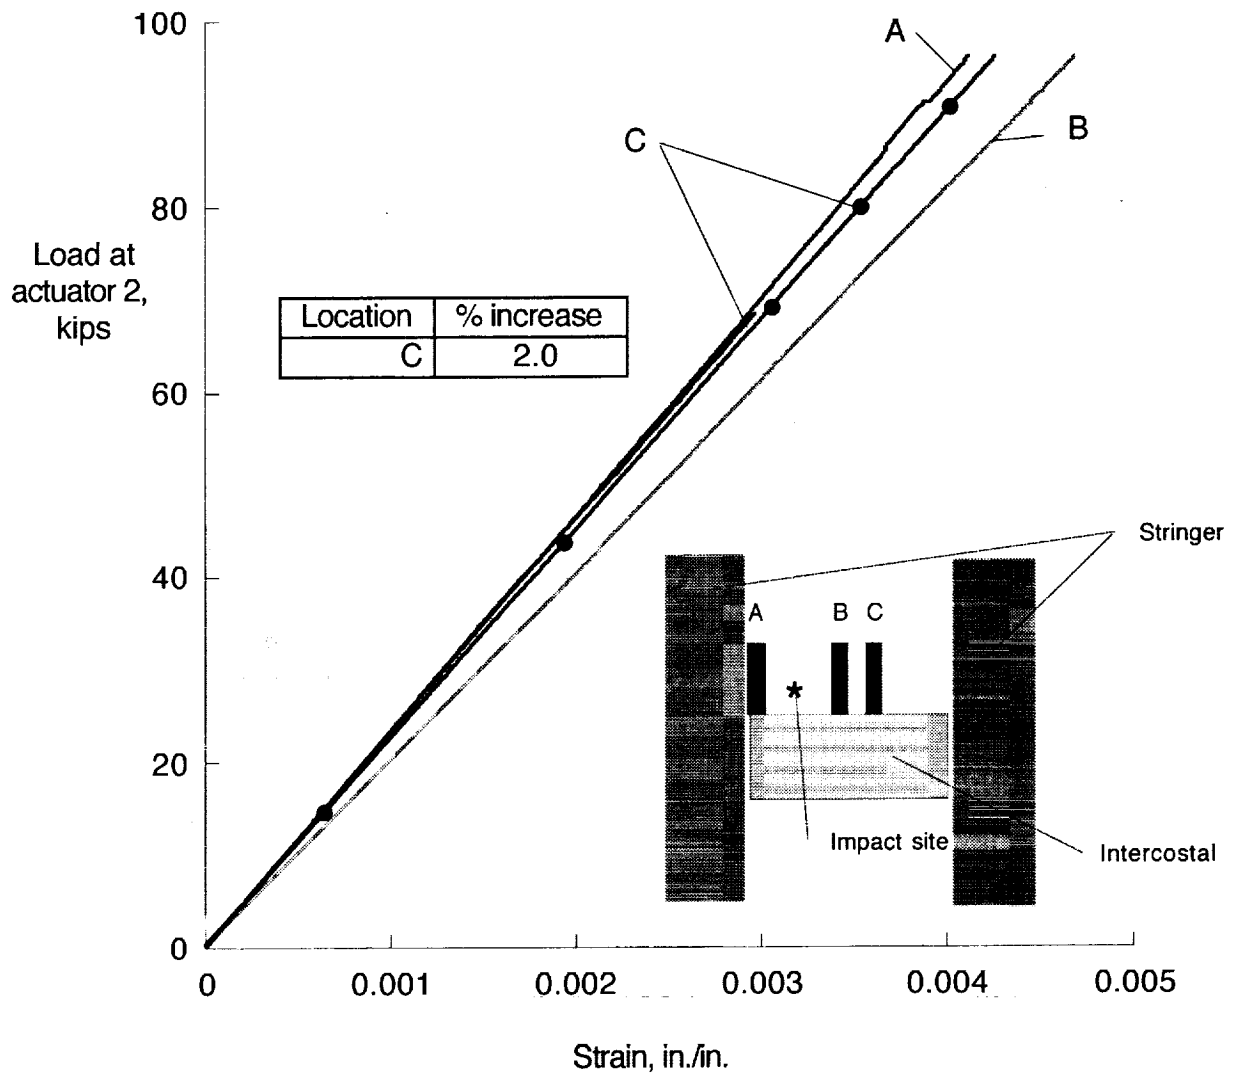
Figure 73. Effect of impact damage on strain in lower cover panel skin adjacent to rib 12. Strain gage and impact locations are shown on figure 13a.

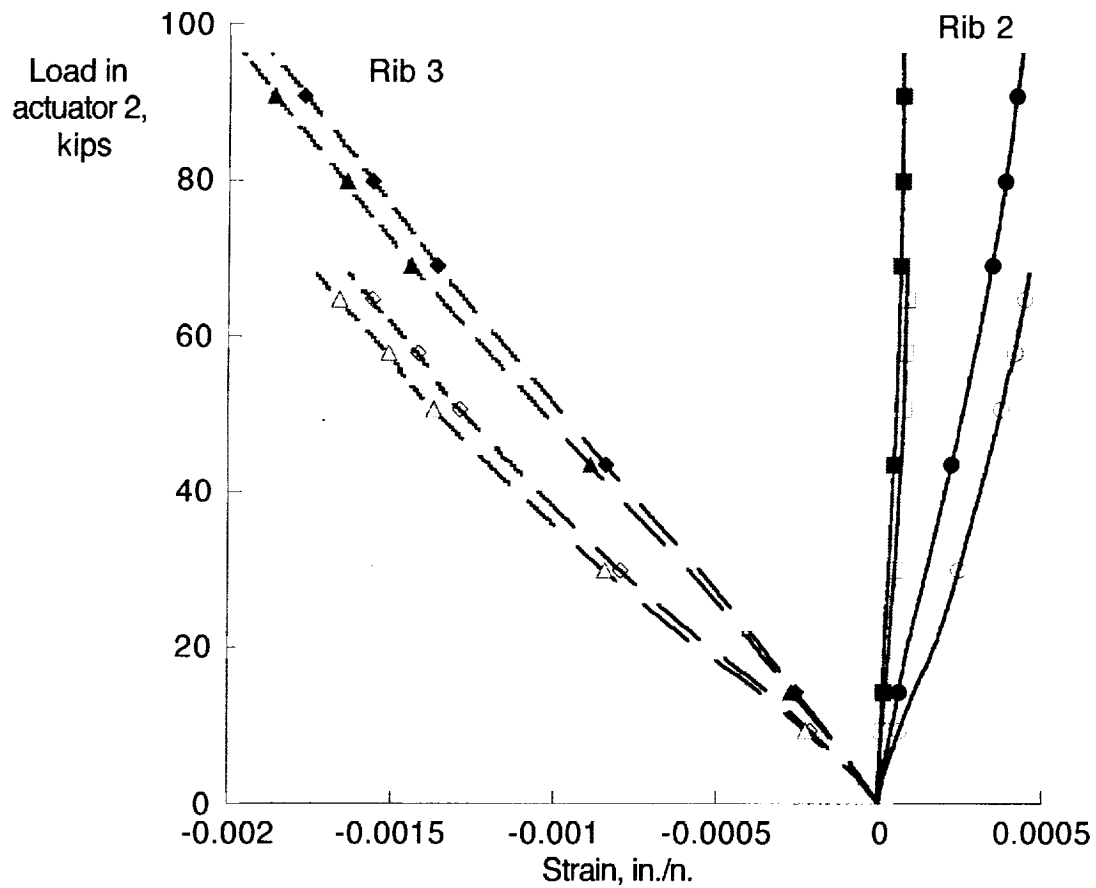
a) Ribs 2 and 3

The effects of the repairs and impacts on the rib strains are shown in figure 74 by presenting results from tests 6 and 8. Strain gage locations are shown in figure 11. The magnitude of the rib strains is small for all ribs. Strains are decreased in ribs 2 and 3 by approximately 25 and 18%, respectively. Strains are nonlinear in these ribs in test 6 but are linear in these ribs in the final test. Strains in ribs 4, 5 and 6 increase but remain less than 0.001 in./in. in magnitude. A sudden increase in strain is seen at a gage on rib 6 near the upper cover intercostal occurs at a load in actuator 2 of 91 kips.

Location	% decrease in strain
Rib 2 web	26
Rib 3 access hole	18

Figure 74. Effect of repair on strain in ribs in 2.5G load condition. Strain gage locations are shown in figure 11.

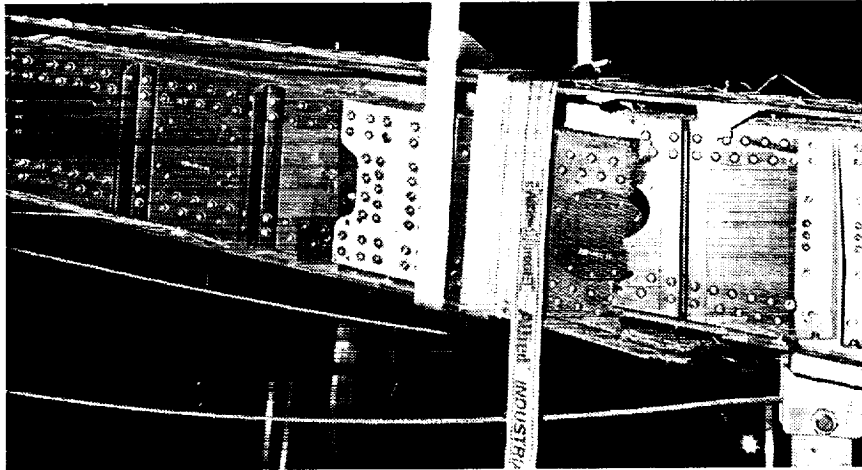
Figure 76. Rear spar after final test.

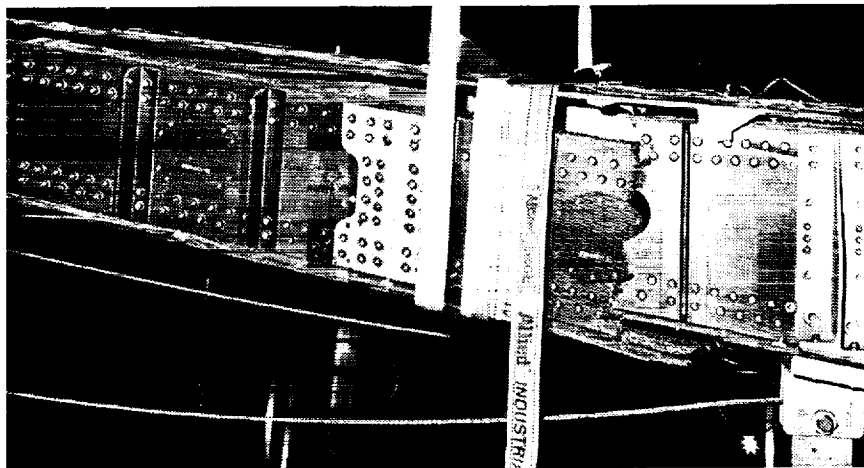
Figure 77. Front spar after final test.

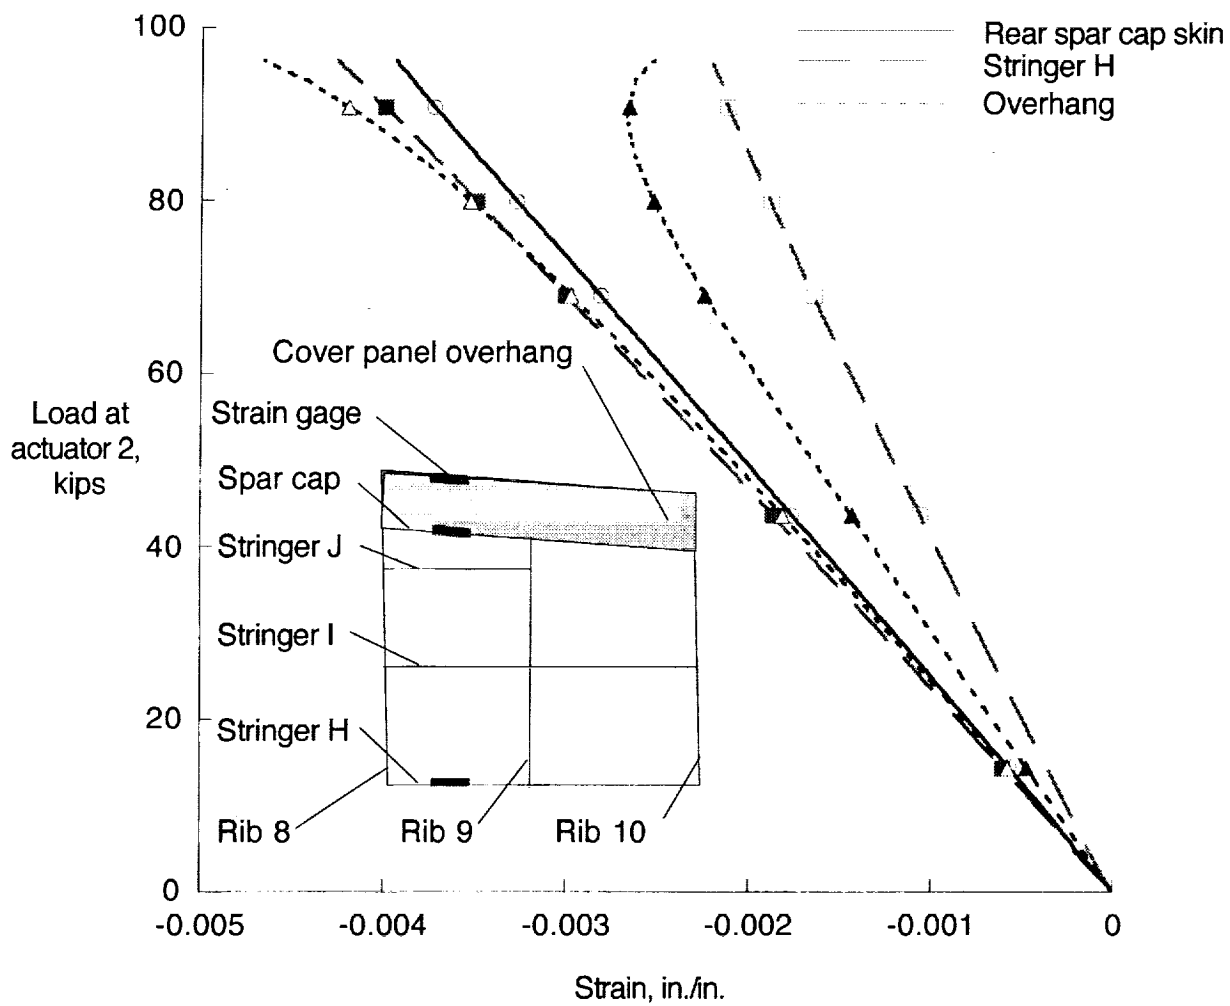
In addition to the global bending behavior illustrated in figure 50, local nonlinear behavior occurred in the upper cover panel to the rear of the rear spar between ribs 8 and 10. An overhang of the cover panel with a width of approximately four inches behind the rear spar left an unsupported edge along the length of the test article. This region is shown on figure 7 as the "critical overhang region." Two back-to-back gages on the skin at the edge of the overhang midway between ribs 8 and 9 indicate that significant local bending occurred. Strains in the upper cover near the rear spar between ribs 8 and 9 are shown in figure 80 for the repaired structure. Open symbols represent strains on the upper skin surface on the cover panel. Filled symbols represent strains on the blade of stringer H and on the lower skin surface of the overhang. For a load less than 70 kips in actuator 2, the local bending effects do not occur (only the global bending effects are seen). However strain reversal is seen in the gages located in the overhang region as load approaches DUL. No other gages were in the overhang region.

Figure 80. Strains in cover panel overhang region behind rear spar.

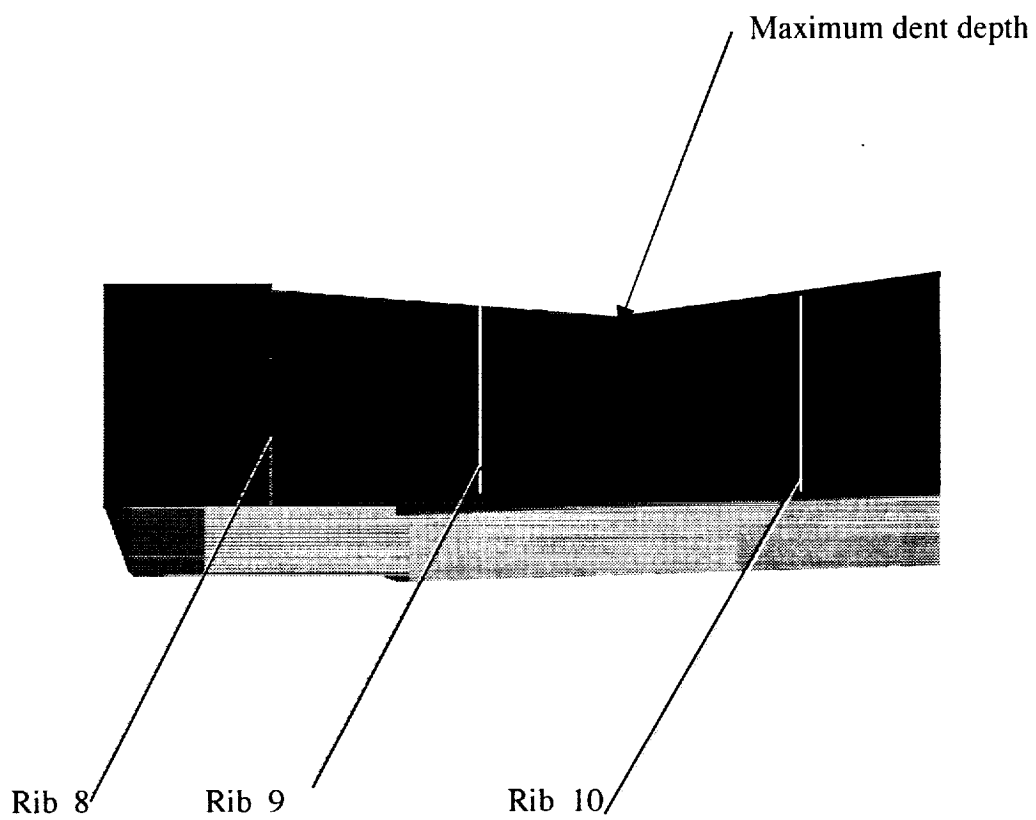
A small initial geometric imperfection in the form of a kink in the upper cover panel was present in the manufactured structure. This kink is centered half way between ribs 9 and 10 and has a maximum depth of 0.1 inches. A sketch of this kink is shown in figure 81. The kink was initially deemed minor enough to have no influence on structural behavior. However, since the kink is in close proximity to a stringer runout and in the region of the upper cover panel which displays local nonlinear behavior in the final test, the possibility that the kink influenced the behavior of the overhang region must be acknowledged. Since only two strain gages were in this region, there is not enough experimental data to explain fully the influence of the kink and the interaction of all components in this region. A detailed finite element analysis which accounts for this imperfection is needed for that. That analysis is beyond the scope of the present paper.

Figure 81. Imperfection in rear of upper cover panel.
